Manhole Inspection Summary

Manhole # S05YY1020MH

Insp Date: **9/7/06 8:44 AM**

Location Address: **5911 WINNER AVE**

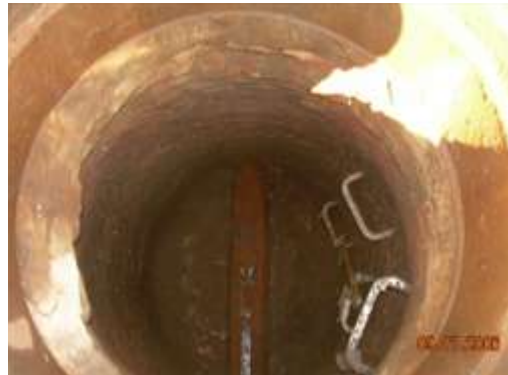
Top View

Surcharge ☒ **Evidence Of Surcharge** Depth: **7** (ft.) ☐ Active Surcharge Present

Evidence of surcharge - Bench debris.

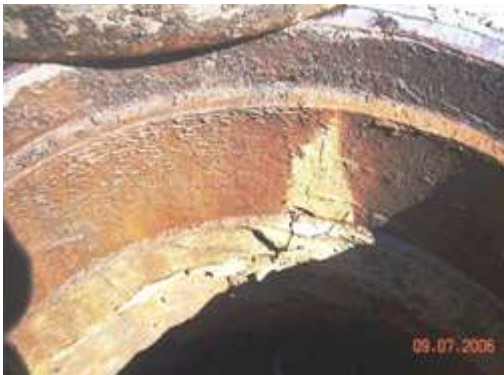
Defect

Frame Offset: **0** (in.) Condition: ☐ Sound ☐ Cracked ☒ **Leaks**

Condition: ☐ Sound ☐ Cracked ☐ Root Intrusion ☐ Loose Brick ☒ **Deteriorated**

Infiltration: ☐ None ☒ **Joint** ☐ Cracks ☒ **Mortar** ☐ Roots ☐ Wall

Infiltration: ☐ None ☐ Joint ☐ Cracks ☒ **Mortar** ☐ Roots ☒ **Wall**

Frame leaks. Adjustment deterioration and infiltration. Corbel infiltration.

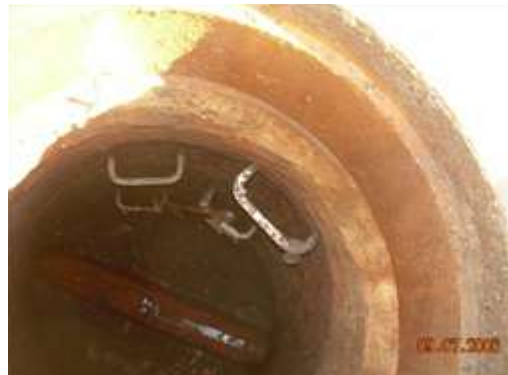
Defect

Frame leaks. Adjustment deterioration and infiltration. Corbel and Barrel infiltration.

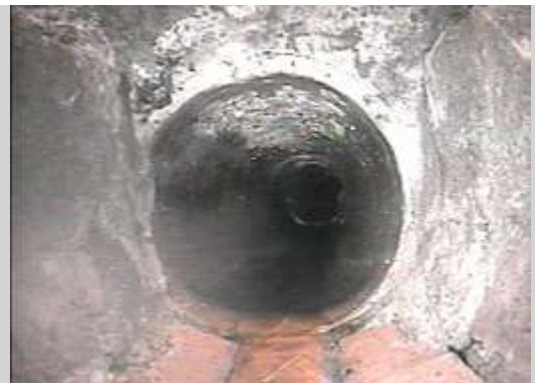
Pipe Out @ 12 O'Clock

Comments **The O12 pipe picture shows grease deposits in the Channel and inside of the pipe.**
